AMP TRANSMISSION, LLC

Amherst 2nd Source Reinforcement Project

*Letter of Notification Application to the Ohio Power Siting Board
Pursuant to Ohio Administrative Code 4906-6-05*

PUCO CASE NUMBER: 22-0956-EL-BLN

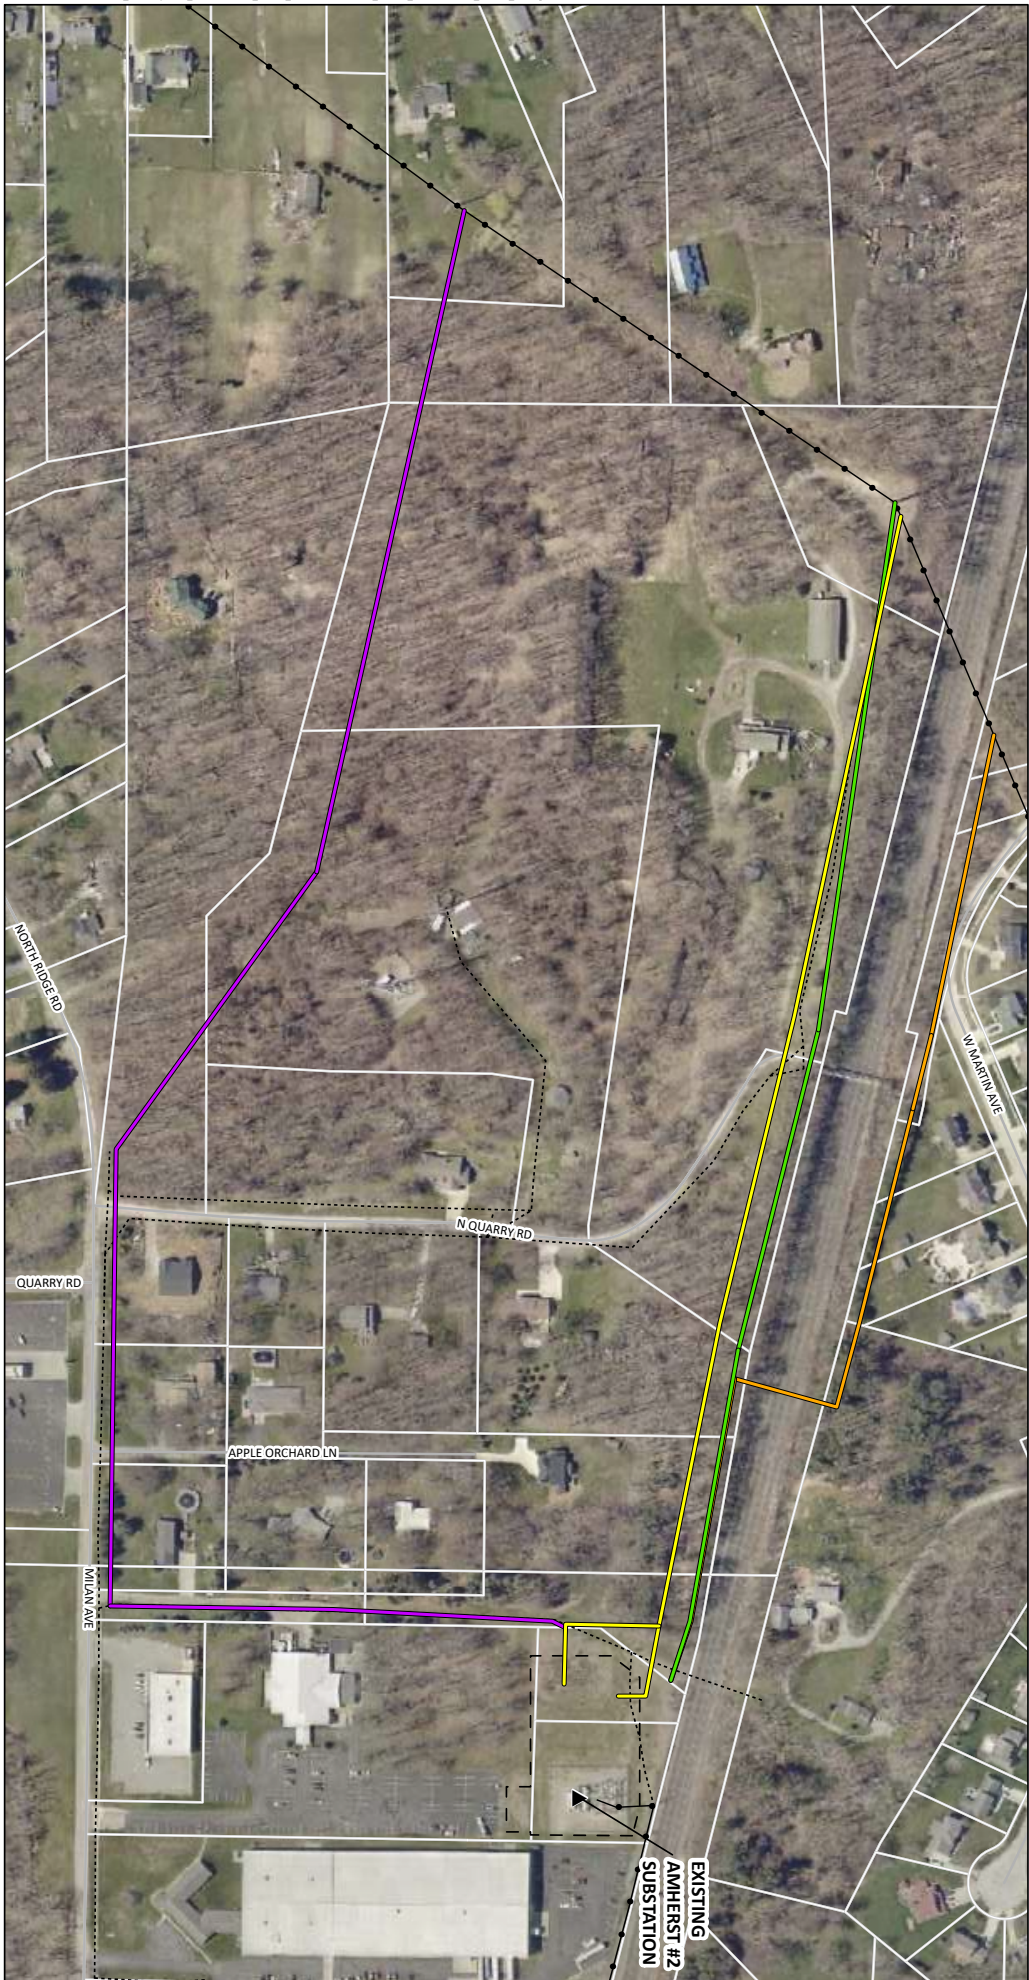
Figure 3: Alternative Transmission Line Routes

<ul style="list-style-type: none"> Substation Alternative Route 1 Alternative Route 2 Alternative Route 3 Alternative Route 4 	<ul style="list-style-type: none"> Proposed Substation Boundary Existing Transmission Line Existing Distribution Line Road Parcel Boundary
---	--

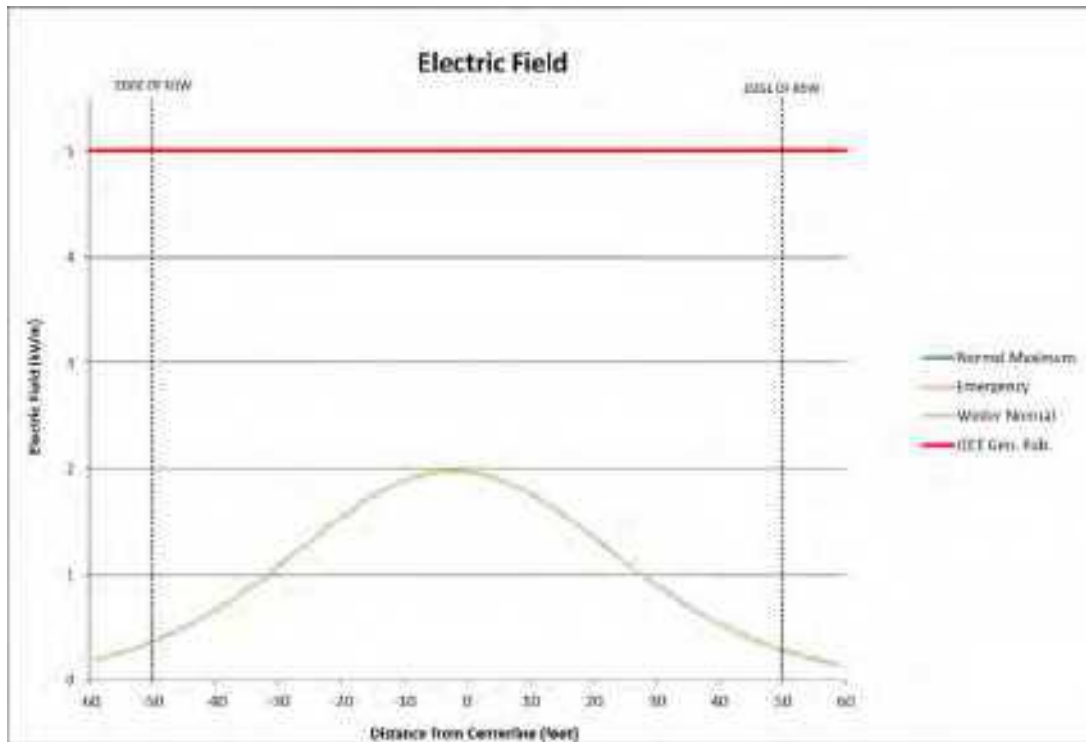
Figure 1: Amherst 2nd Source Transmission Line Electric Fields

Figure 1 shows the electric fields across the ROW for the Amherst 2nd Source transmission line. Electric field is driven by the voltage of the line. Therefore, the results shown in Figure 1 for each of the three loading cases are identical as the voltage of the line remains at 145 kV (105% of 138 kV nominal).

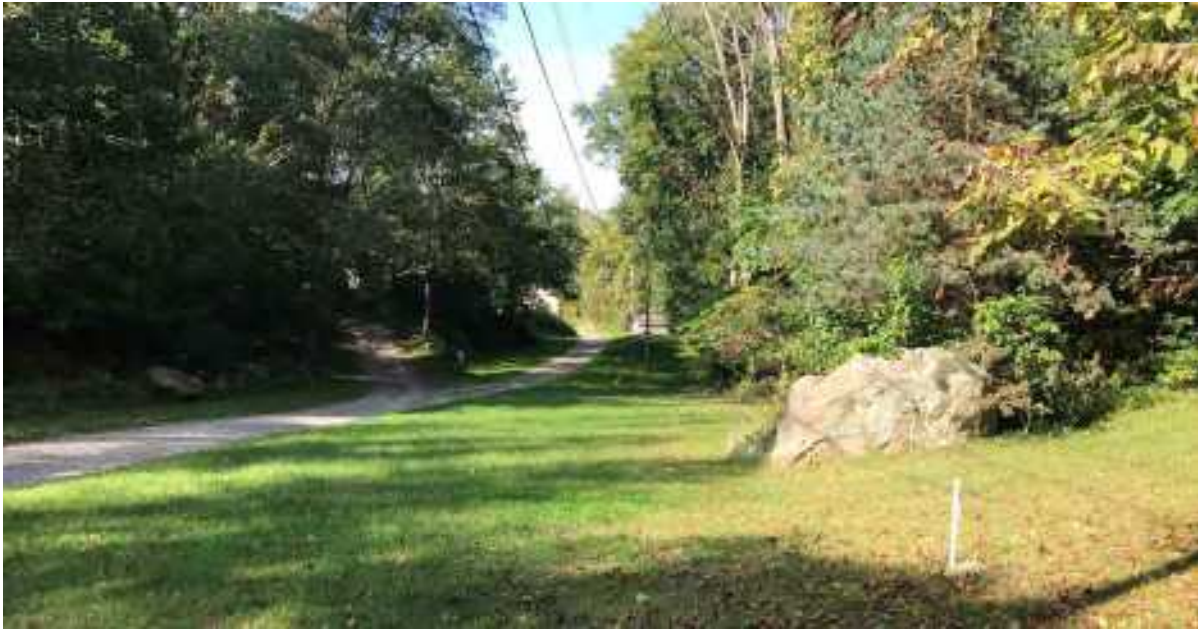
The project is within the range of the black-crowned night-heron (*Nycticorax nycticorax*), a state-threatened bird. Night-herons are so named because they are nocturnal, conducting most of their foraging in the evening hours or at night, and roost in trees near wetlands and waterbodies during the day. Night herons are migratory and are typically found in Ohio from April 1 through December 1 but can be found in more urbanized areas with reliable food sources year-round. Black-crowned night-herons primarily forage in wetlands and other shallow aquatic habitats, and roost in trees nearby. These night-herons nest in small trees, saplings, shrubs, or sometimes on the ground, near bodies of water and wetlands. If this type of habitat will be impacted, construction should be avoided in this habitat during the species' nesting period of May 1 through July 31. If this type of habitat will not be impacted, this project is not likely to impact this species.

The project is within the range of the spotted turtle (*Clemmys guttata*), a state threatened species. This species prefers fens, bogs and marshes, but also is known to inhabit wet prairies, meadows, pond edges, wet woods, and the shallow sluggish waters of small streams and ditches. Due to the location, the type of habitat within the project area, and the type of work proposed, this project is not likely to impact this species.

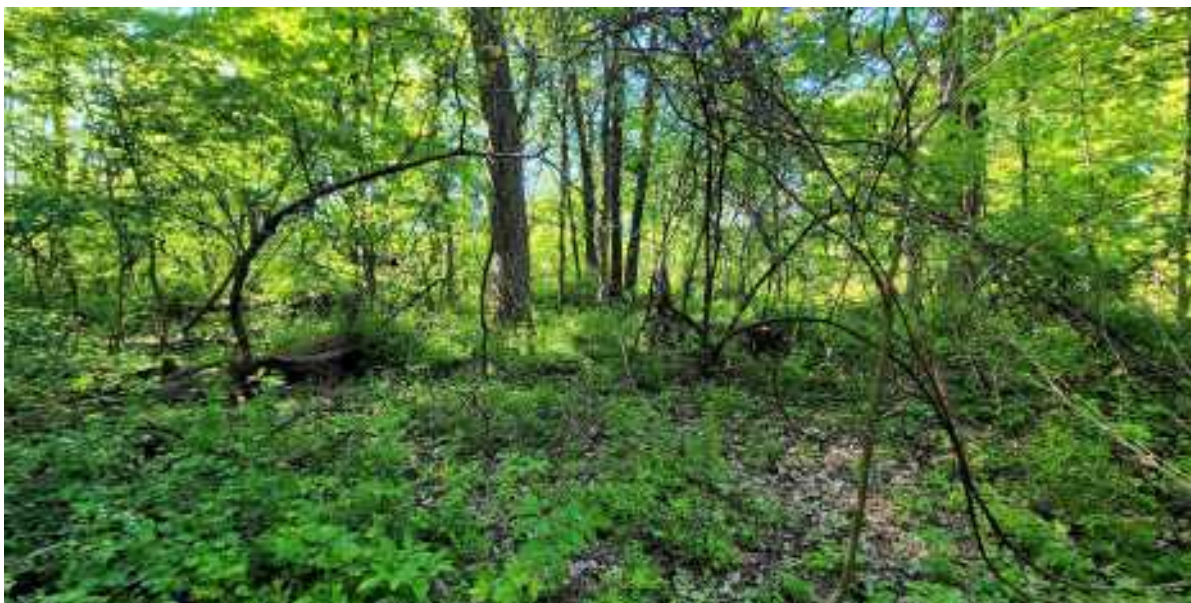
The project is within the range of the northern harrier (*Circus hudsonis*), a state endangered bird. This is a common migrant and winter species. Nesters are much rarer, although they occasionally breed in large marshes and grasslands. Harriers often nest in loose colonies. The female builds a

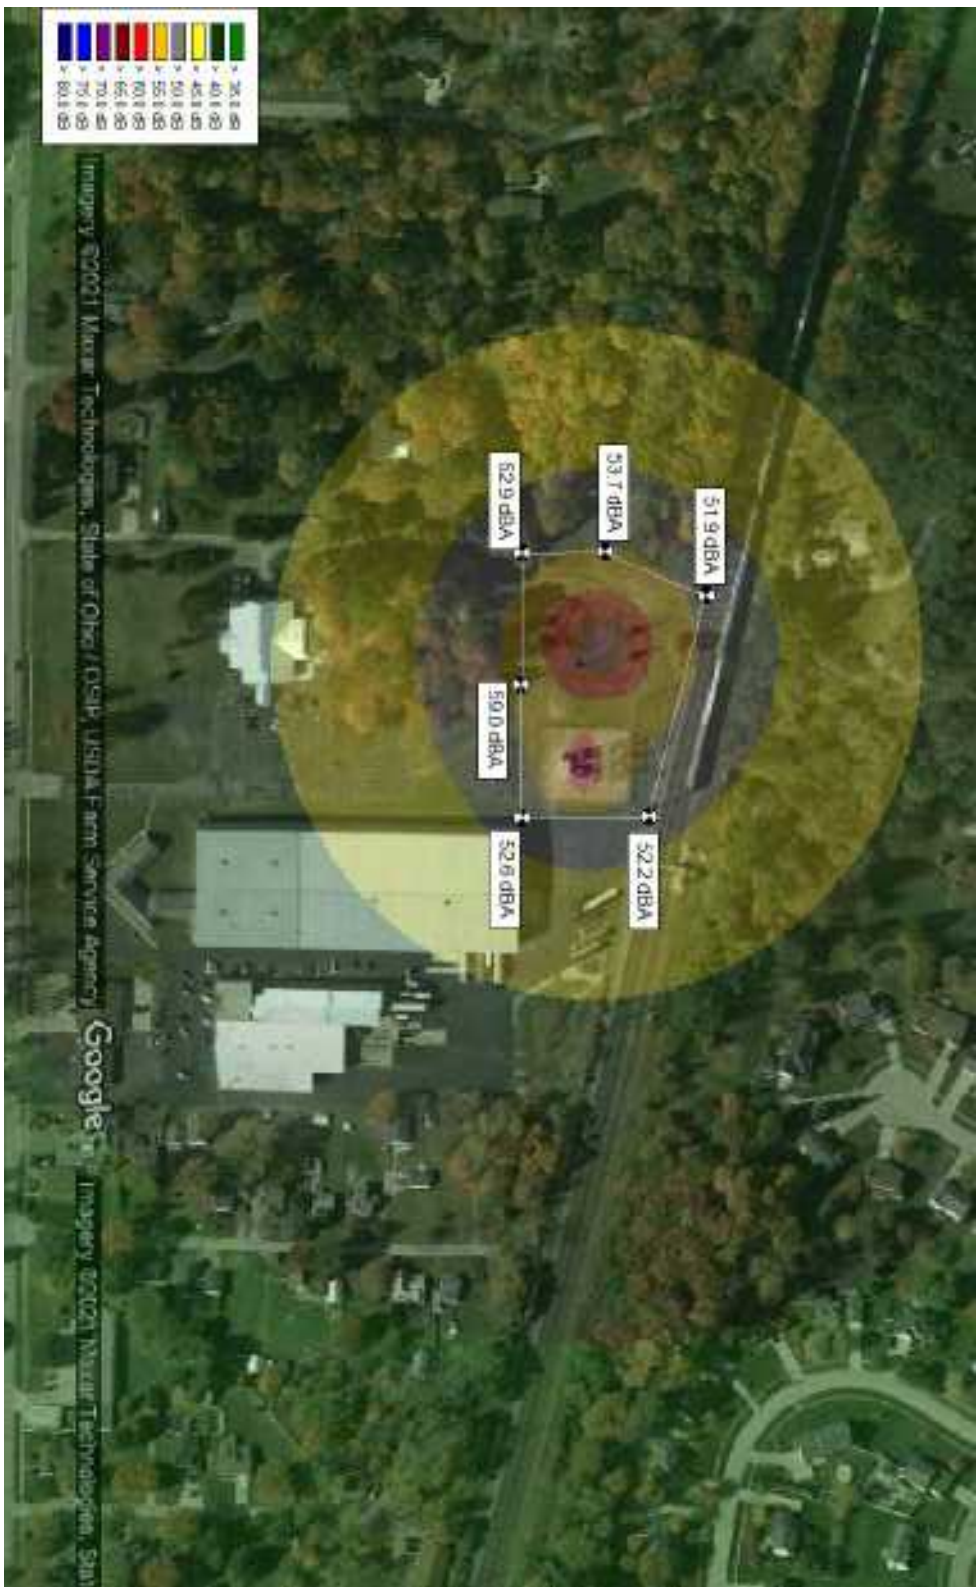
Figure 3: Calculated Noise Contour at Maximum Operation
